Monitoring Data RecordProject Title: R-2417BB (Site 6) COE Action ID: 200201326Stream Name: _____ DWQ Numbers: 3378City, County and other Location Information: Lee County, Sanford Bypass (Sta. 540+20 to 555+00 -L- RT.)Date Construction Completed: Water was turned into the stream in Oct. 2006. Streambank reforestation was completed in Jan. 2007.Monitoring Quarter: (4) of 8Ecoregion: _____ 8 digit HUC unit: 03030004

Section 1. PHOTO REFERENCE SITES**Total number of reference photo locations at this site:** 9 photo point locations – 2 photos taken from each location**Dates reference photos have been taken at this site:** 5/21/07, 8/7/07, 11/2/07, 2/1/08**Individual from whom additional photos can be obtained (name, address, phone):** _____

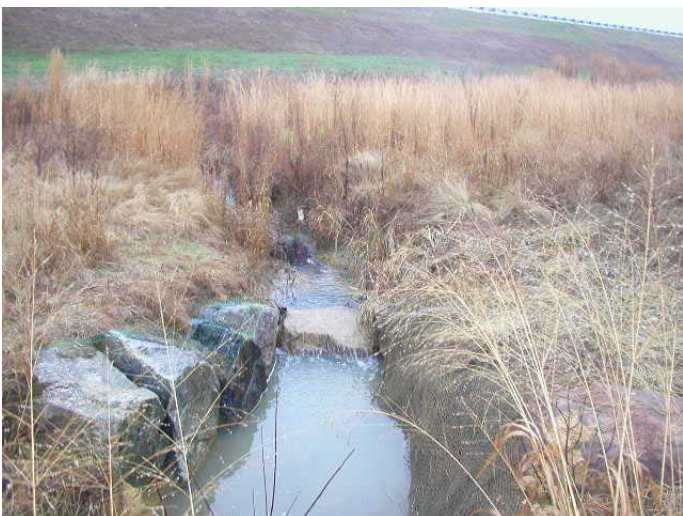
Photo Point #6 (Upstream)

This is the 4th quarterly monitoring evaluation for this stream relocation. The crossvane @ Sta. 546+75 (PP#6 Upstream) that was noted previously as having water piping under the crossvane, a slight headcut, and the left arm of the crossvane had dropped into the channel has been repaired and is functioning properly at this time. The stream relocation is stable at this time. NCDOT will continue to monitor this stream relocation.
